SUMMIT HOME INSPECTIONS

# Home Inspection Report

**1425 Maplewood Drive, Ann Arbor, MI 48103**

**Inspection Date:** March 12, 2026  
**Inspector:** Sam Rivera  
**Weather:** Partly cloudy, 54°F

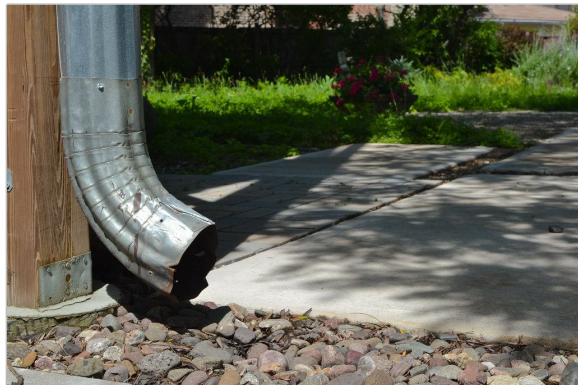
### **PROBLEM** Grading slopes toward foundation at rear elevation

Soil and mulch beds along the rear elevation slope toward the house, and the northeast downspout discharges at the base of the wall without an extension. Surface water directed at the foundation is the most common source of basement moisture. Regrade to fall away from the structure (approximately 6 inches over the first 10 feet) and add downspout extensions that discharge at least 4 feet from the foundation.

Downspout discharging at rear foundation

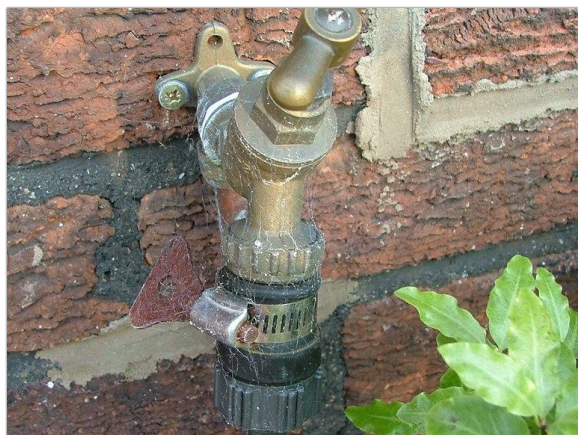
### **PROBLEM** Hose bibb lacks backflow protection

The exterior hose bibb on the south wall has no anti-siphon (vacuum breaker) device. Without backflow protection, a drop in supply pressure can draw contaminated water from an attached hose back into the potable system. Screw-on vacuum breakers are an inexpensive correction; recommend installing one at each exterior faucet.

South wall hose bibb

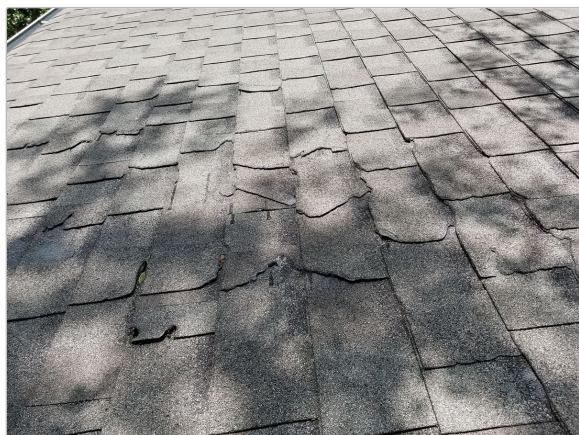
### **PROBLEM** Shingles at end of service life on south-facing slope

The architectural asphalt shingles show granule loss, edge curling, and scattered cracked tabs concentrated on the south-facing slope. The roof covering appears original to the last replacement cycle (estimated 18-20 years old) and is approaching the end of its useful service life. Budget for replacement within the next 1-3 years; have a licensed roofing contractor evaluate.

Granule loss and curling, south slope

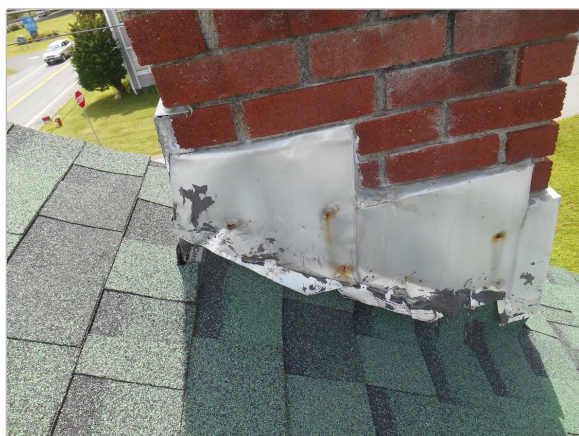
### **PROBLEM** Chimney flashing lifted; sealant failing

Counter-flashing at the chimney base is lifted on the uphill side and the sealant has weathered out. This is a common moisture-entry point and corresponds with staining observed on the chimney chase framing in the attic. Re-secure and reseal the flashing, or replace during roof covering replacement.

Chimney base flashing, uphill side

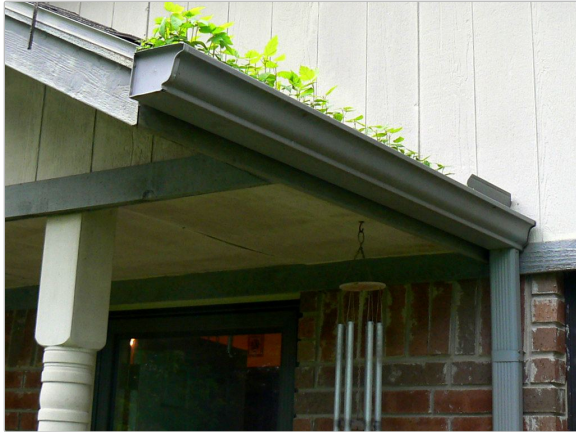
### **SERVICEABLE** Gutter debris accumulation at rear

Gutters and downspouts are functional, but the rear runs hold enough organic debris that seedlings are sprouting from the gutter above the porch. Clean seasonally so runoff is carried to the downspouts rather than overflowing at the eaves.

Seedlings sprouting from rear gutter

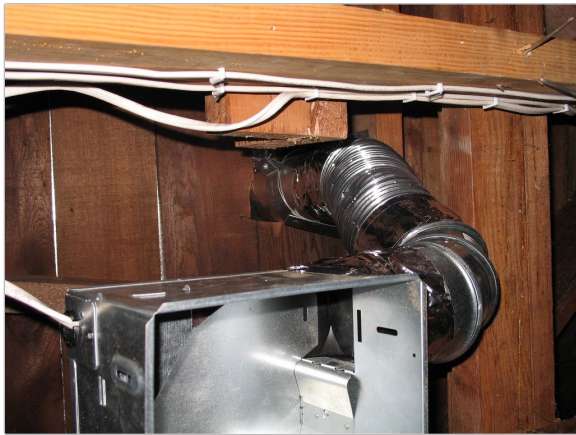
### **PROBLEM** Bathroom exhaust duct terminates in attic

The hall bathroom exhaust fan duct ends in the attic space near the north gable rather than continuing to the exterior. Warm, moist air released into the attic condenses on the underside of the roof sheathing and can support mold growth. Extend the duct to an exterior termination with a dampered hood.

Hall bath exhaust fan duct in attic

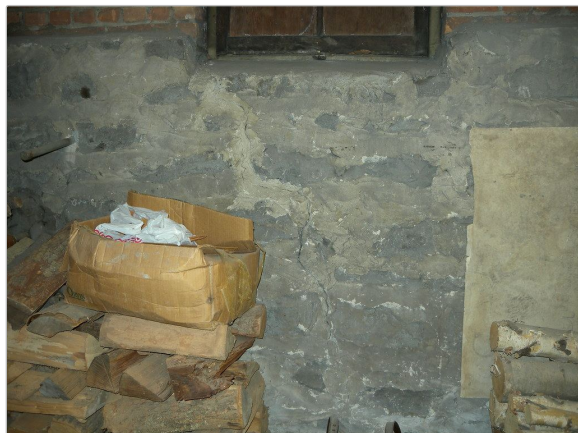
### **PROBLEM** Vertical crack with efflorescence, northeast foundation wall

A hairline-to-1/8" vertical crack in the northeast poured foundation wall shows efflorescence (white mineral deposits), indicating periodic moisture movement through the crack. No measurable displacement was noted. Seal the crack (epoxy or polyurethane injection), correct exterior drainage at this corner (see Exterior), and monitor for change.

Vertical crack, northeast wall

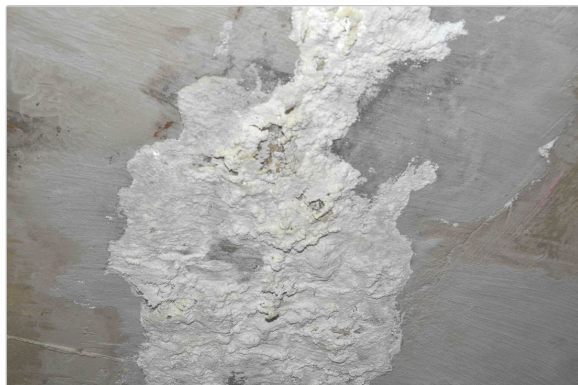
### **PROBLEM** Moisture staining at base of west wall

Staining and mineral deposits at the base of the west wall indicate past seepage. Surfaces were dry at the time of inspection despite rain within the previous 48 hours. Improving gutter discharge and grading on this side should be the first corrective step before considering interior drainage measures.

Mineral staining at base of west wall

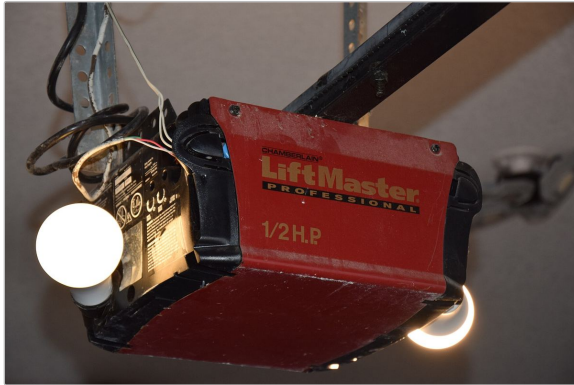
### **PROBLEM** Overhead door opener fails auto-reverse contact test

The overhead door opener did not reverse when the door was obstructed at the floor (contact test). The photoelectric eyes responded correctly. An opener that fails the contact test is an entrapment hazard, particularly for children. Adjust the down-force setting or have the opener serviced, then retest.

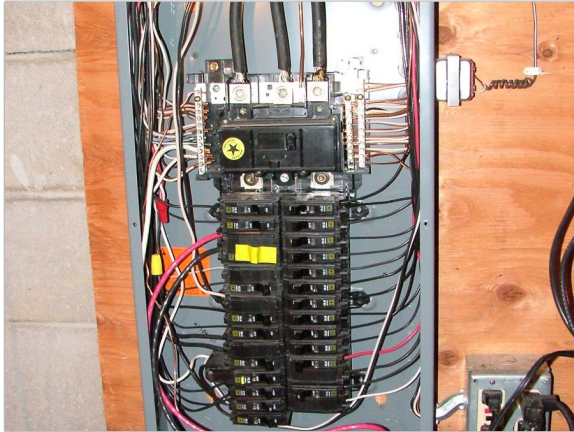
### **PROBLEM** Double-tapped breakers in main panel

Two circuits in the main panel share single-pole breakers not rated for two conductors (double-tap). Loose connections at double-taps are a common overheating point. Have an electrician move the shared conductors to their own breakers or install breakers listed for two conductors.

Panel interior — shared breaker terminations

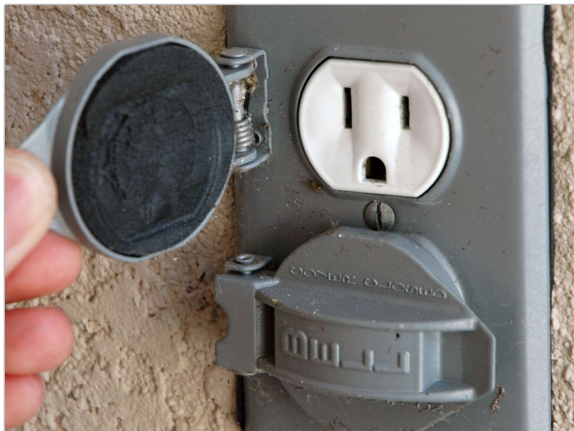
### **PROBLEM** Exterior receptacles lack GFCI protection

The rear patio receptacle carries a "GFCI protected" label, but neither it nor the front porch receptacle tripped with a test device — no working ground-fault protection was found on the exterior circuits. Exterior outlets require GFCI protection because of shock risk in wet locations. An electrician can protect these with GFCI receptacles or a GFCI breaker.

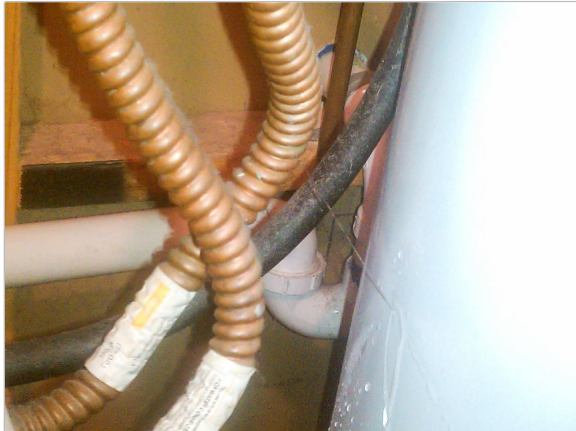
### **PROBLEM** TPR discharge pipe terminates too high above floor

The temperature-pressure relief valve discharge pipe on the water heater ends approximately 18 inches above the floor. A discharge terminating more than 6 inches above the floor can scald a bystander if the valve releases. Extend the pipe to within 6 inches of the floor using approved material.

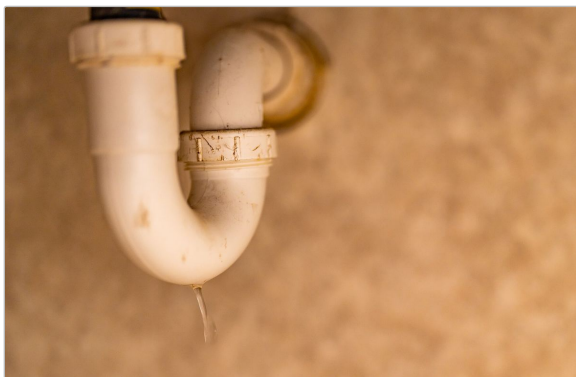
### **PROBLEM** Active drip at bathroom sink trap

The P-trap under the hall bathroom sink shows an active drip at the slip-joint connection, with mineral staining on the fittings. The trap washers should be re-seated or the trap assembly replaced, and the cabinet base checked for moisture damage once the leak is corrected.

Drip at trap slip joint, hall bathroom

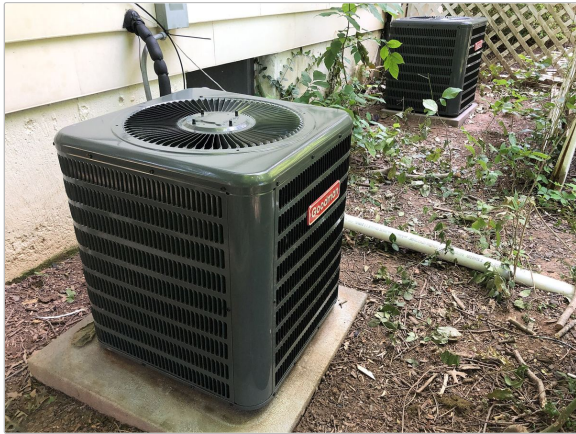
**PROBLEM Air-conditioning condenser beyond typical service life**

The exterior condensing unit (manufactured 2005) started and cooled at the time of inspection, but at 21 years old it is well beyond the typical 12–15 year service life for central air equipment, and the refrigerant type (R-22) is no longer produced. Budget for replacement; repairs requiring refrigerant will be disproportionately expensive.

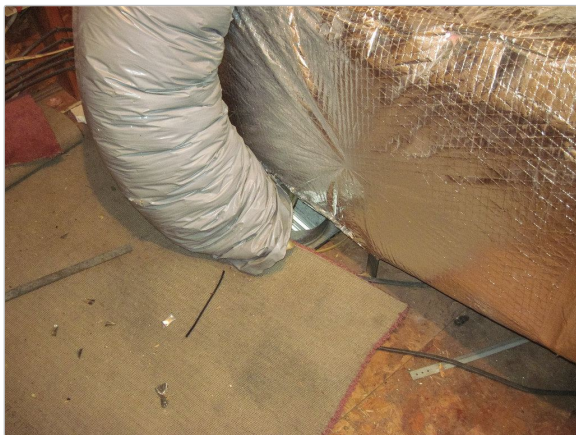
**PROBLEM Kinked flexible duct restricting airflow**

The flexible supply duct serving the rear bedroom is sharply kinked and beginning to pull apart at the register boot in the attic, reducing airflow to the room. Re-secure the connection and re-support the duct to restore a full interior diameter, or replace the run with rigid duct.

Kinked flex duct at register boot

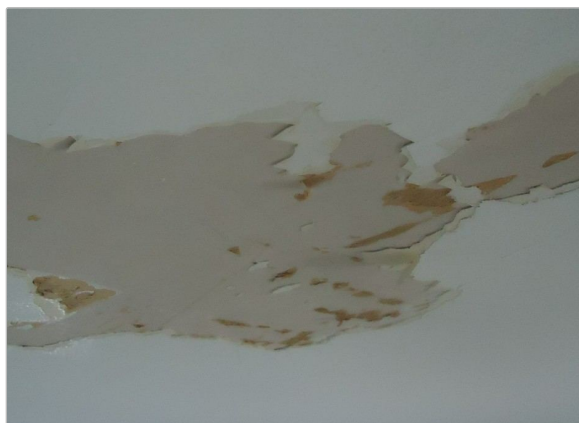
**PROBLEM** Moisture damage on ceiling below hall bathroom

Brown staining and peeling paint on the dining-room ceiling align with the hall bathroom tub drain above. Moisture-meter readings at the stain were slightly elevated. The tub overflow gasket and drain connections should be evaluated and repaired before the ceiling is refinished; observe after repairs to confirm the leak is resolved.

Stain at dining-room ceiling below hall bath

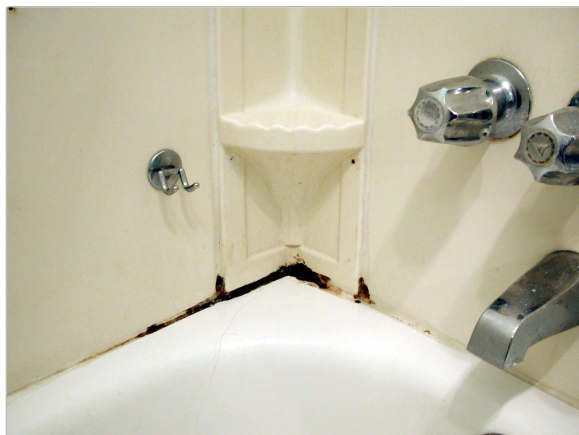
**PROBLEM** Failed caulk at tub surround

Caulk joints at the hall bathroom tub surround are cracked and separating, and grout is missing at several tile joints. Open joints admit water behind the surround and are the likely contributor to the ceiling stain below. Rake out and recaulk the joints; regrout open tile lines.

Separated caulk joint at tub surround

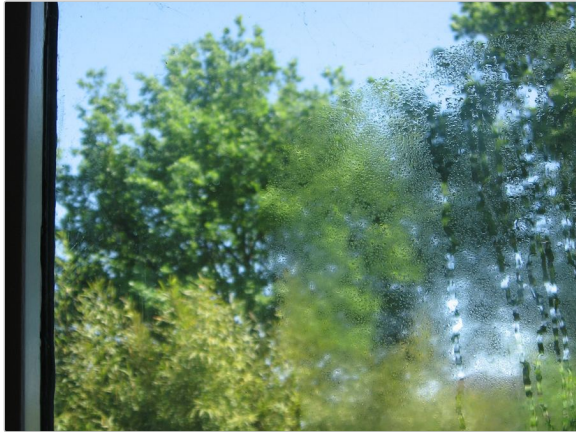
### **PROBLEM** Failed thermal seals at two windows

Two double-pane units — the living-room picture window and the north bedroom window — show fogging between the panes, indicating failed insulated-glass seals. This is a comfort and cosmetic issue rather than structural; the sashes or glass units can be replaced individually.

Interpane condensation, living-room window

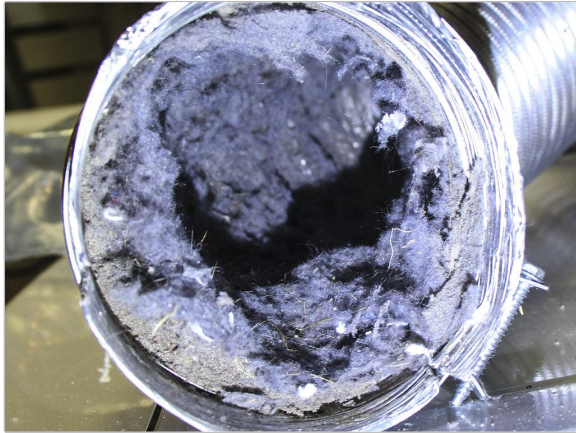
### **PROBLEM** Foil flex duct on dryer exhaust, heavy lint accumulation

The dryer is vented with corrugated foil flex duct, and the duct interior is heavily lined with lint at the dryer connection. The ridged interior traps lint and the material is easily crushed — a recognized fire hazard and a restriction on dryer performance. Replace with smooth-wall rigid or semi-rigid metal duct and clean the full exhaust run.

Lint accumulation inside dryer flex duct
